**Date of Incident: 10.03.2009**  
**Reporting Date: 10.03.2009**  
**Ref. No: 01/2009**  
**Name of the Vessel: M/T SURMENE KA**

**NEAR MISS ACCIDENT  
 (LEFT FEMORIS MUSCLE  
 INJURY) IZMIT PORT**

# TRANS KA Safety Alert Bulletin

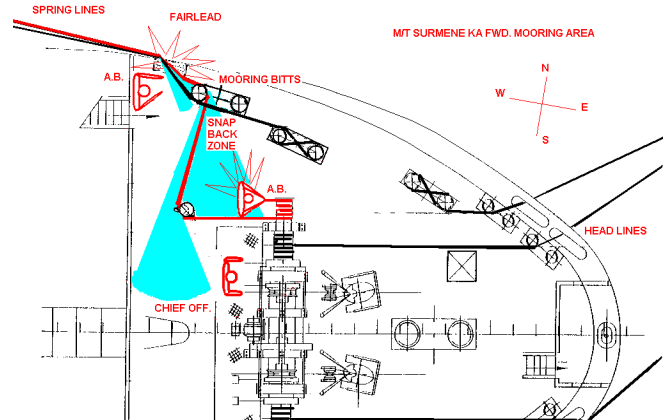
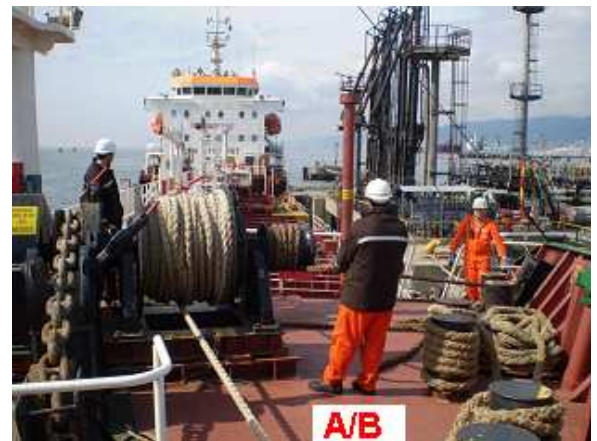
In order to take in the slack of the ropes that had been slacken with the impact of freshened westerly wind (5-6 in beaufort scale) and of loading at the quay Faz 1D of Tupras, on 10.03.2009 at 17:50, the Chief Officer and two A/Bs had come to the forward mooring area. Taking in the slack of one of the spring lines had been initiated after it had been taken onto a mooring winch drum. The A/B X was holding the rope on the drum. The rope had been tightened to use a stopper. This very moment (18:00), the vessel had moved forward due to the strong wind blowing from the back of the vessel. Precisely through the spring fairlead, spring line was parted and hit X's left leg right on the femoris area.

- At particular times when there is strong wind, ropes/wires should be checked more often.
- All tension should never be loaded onto a single rope/wire, there must be at least 2 ropes/wires on which the tension is burdened.
- When possible, breast lines must definitely be used.
- As well as cleanliness and tidiness of the maneuvering area, snap back zone must also be marked and painted in order to attract the personnel's attention.
- For that purpose, below guiding pictures must be used.
