**Date of Incident: 10.03.2009**  
**Reporting Date: 10.03.2009**  
**Ref. No: 01/2009**  
**Name of the Vessel: M/T SURMENE KA**

**NEAR MISS ACCIDENT  
 (LEFT FEMORIS MUSCLE  
 INJURY) IZMIT PORT**

# TRANS KA Safety Alert Bulletin

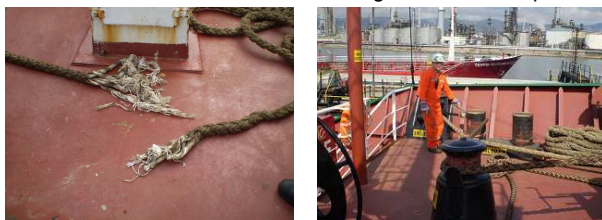
The Chief Officer immediately laid him on his back and put him in a stable position. In the first visual controls, there was not seen any bleeding or fractured body part. Then, an ambulance was called in from the terminal. At 18:15, the A/B was taken to the Derince State Hospital with the accompaniment of the Second Officer. At 18:40, his medical examination was carried out and he was diagnosed with left femoris muscle injury. His condition was monitored for the next 1,5 hour and then he was discharged from the hospital.
